Property Inspection Report

123 Main St, St Petersburg, FL 33703
Inspection prepared for: Sample Inspection
Date of Inspection: 9/18/2016 Time: 12pm
Age of Home: 2001 Size: 1800 sq ft
Weather: Sunny, Warm

Inspector: Glenn Fricke
License #HI1806, CRC132966
212 28th St S, St Petersburg, FL 33712
Phone: 727-642-2793
Email: Glenn@dgciflorida.com
www.dgciflorida.com

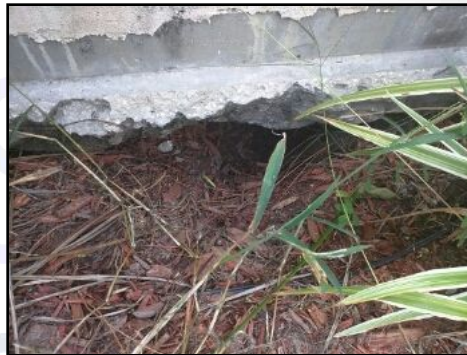
1.1. Animal burrowing was found at one or more areas. It is unknown what type of animal this is or if this is active. Client should follow up with seller, or monitor moving forward. An animal removal expert/trapper may need to be called.

Animal Burrowing rear pool deck area

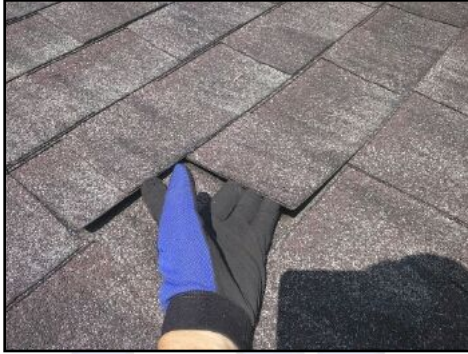
3.1. Composition shingles were loose because the adhesive, self-sealing strips weren't sealed. Leaks can occur as a result. Self-sealing strips secure the lower edge of shingles and reduce vulnerability to wind damage. Strips may not be sealed because the sealant has failed or because the sealant never activated and cured after the original installation. Recommend that a qualified contractor repair as necessary. For example, by hand sealing shingles with an approved sealant.

Seal strips loose

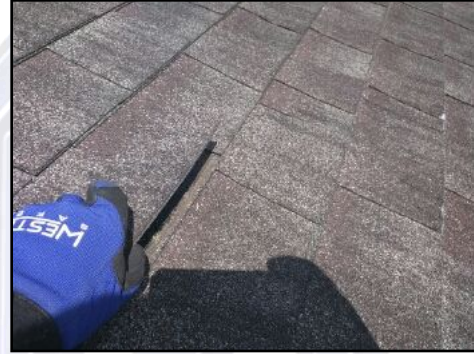
Seal strips loose

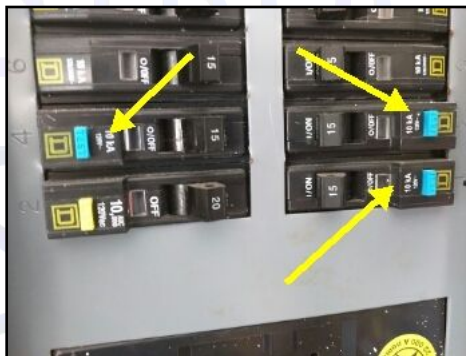
| Electrical | | |
|---|---|--|
| Page 7 Item: 4 | Circuit Breaker Observations | 4.1. One or more circuit breakers in panel(s) A appeared to be of a type that have been recalled (Square D or Homeline AFCI, from 4/04 to 9/04, with a blue test button). Recommend that a qualified electrician evaluate and replace circuit breakers if necessary. |

4.1. One or more circuit breakers in panel(s) A appeared to be of a type that have been recalled (Square D or Homeline AFCI, from 4/04 to 9/04, with a blue test button). Recommend that a qualified electrician evaluate and replace circuit breakers if necessary.

Recalled breakers blue test button

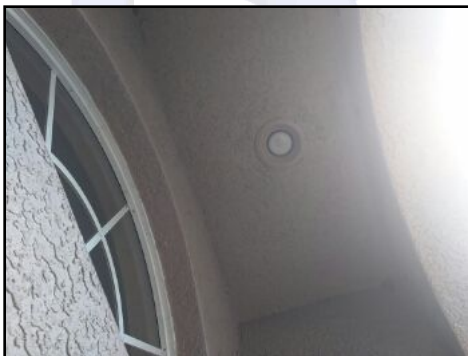
7.1. One or more light fixtures were inoperable (didn't turn on when nearby switches were operated). Recommend further evaluation by replacing bulbs and/or consulting with the property owner (perhaps on a switch that was not identified). If replacing bulbs doesn't work and/or no other switch(es) can be found, then recommend that a qualified electrician evaluate and repair or replace light fixtures as necessary.

Front porch light out, check bulb

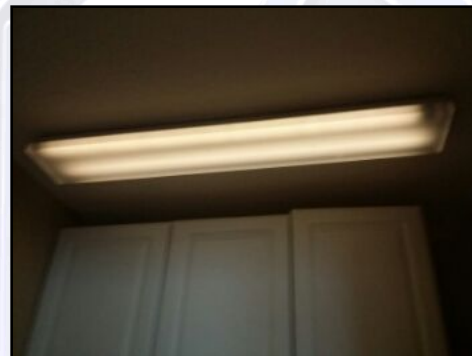
Ballast low in fluorescent

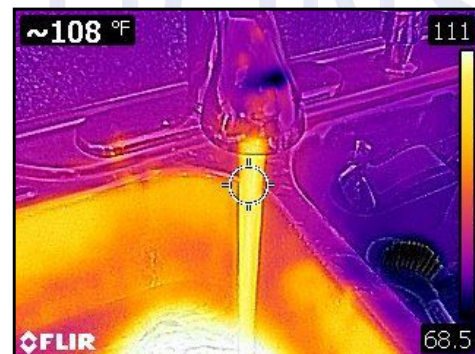
Hot water temperature 108 degrees

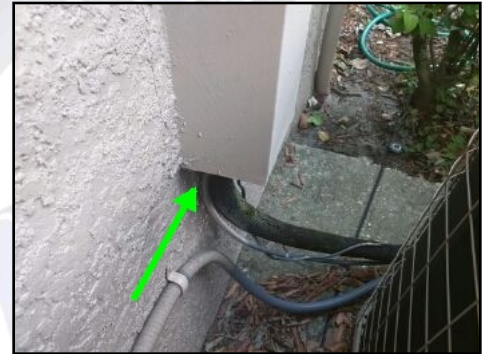
Spray foam shroud shut

1.1. Recommend the client spray foam shut the HVAC shroud to prevent rodents from climbing into the attic.

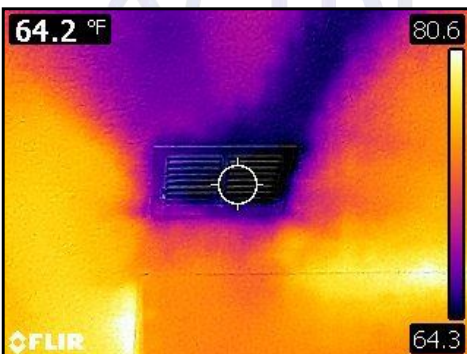
2.1. Air registers were viewed with infrared thermal imaging. Temperature differential between the return air and the supply registers was within the normal 14-20 degree difference.

Air conditioning functional, temperature 64 degrees

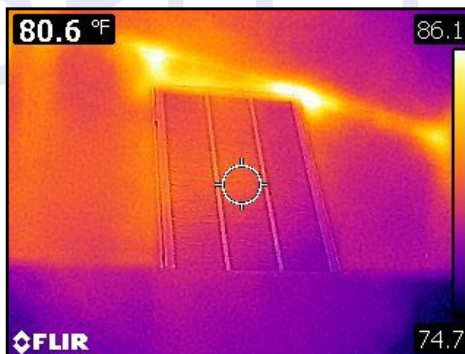
Return temp 80 degrees

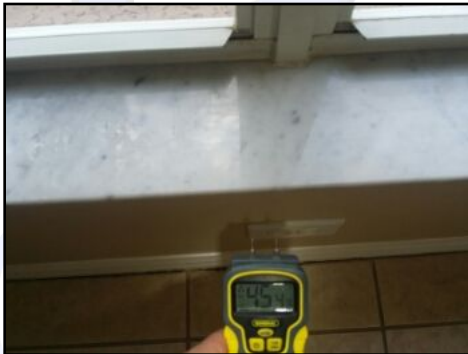
| Electrical | | |
|---|---|--|
| Page 12 Item: 2 | Window Observations | 2.1. One or more windows appeared to be leaking. Recommend contractor evaluate and repair. |

2.1. One or more windows appeared to be leaking. Recommend contractor evaluate and repair.

Elevated moisture rear dining area window array

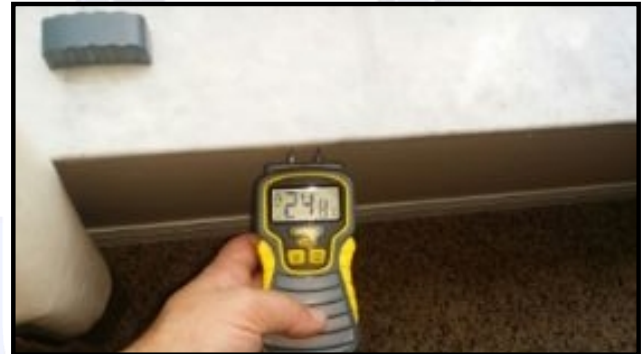
Elevated moisture levels below master bedroom window

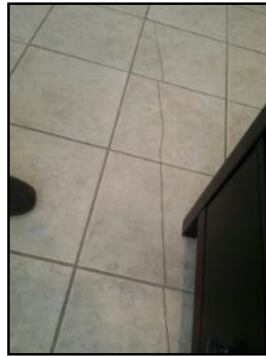
4.1. Tile or grout in the flooring in one or more areas was damaged or deteriorated. Recommend that a qualified contractor repair as necessary.

Large floor tile cracks present throughout house

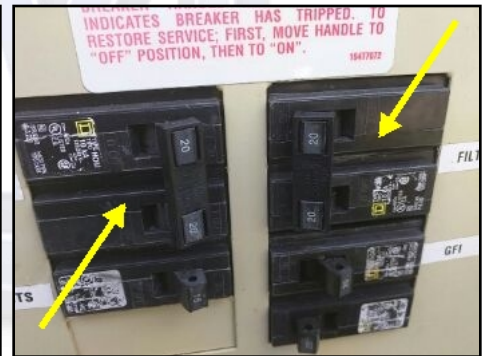
5.1. **GFCI** protection was not visible for one or more heaters and pumps. Pumps and heaters are now required to have GFCI protection. A qualified electrician should evaluate and repair as necessary.

Recommend GFCI on pool pumps, heater

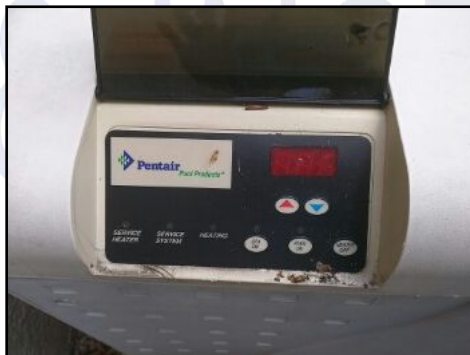
| Electrical | | |
|---|---|--|
| Page 14 Item: 6 | Pool Heater Observations | 6.1. The heaters were inoperable. A qualified contractor should evaluate and repair as necessary. |

6.1. The heaters were inoperable. A qualified contractor should evaluate and repair as necessary.

Spa heater inoperable

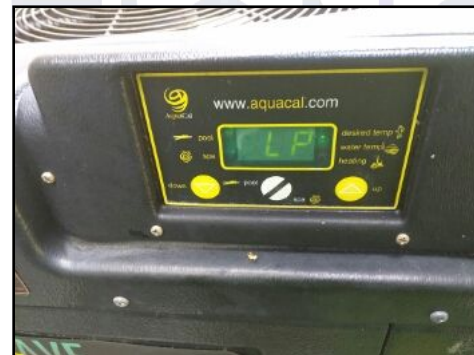
Pool Heater inoperable
